Managing Geotechnical Risk Through Non-Destructive Rock Reinforcement Testing Trialed at the George Fisher Mine, Mt Isa

Wouter Hartman
Principal Geotechnical Engineer

Second Australian Ground Control in Mining Conference
Sydney, UNSW, Australia
23th November 2010

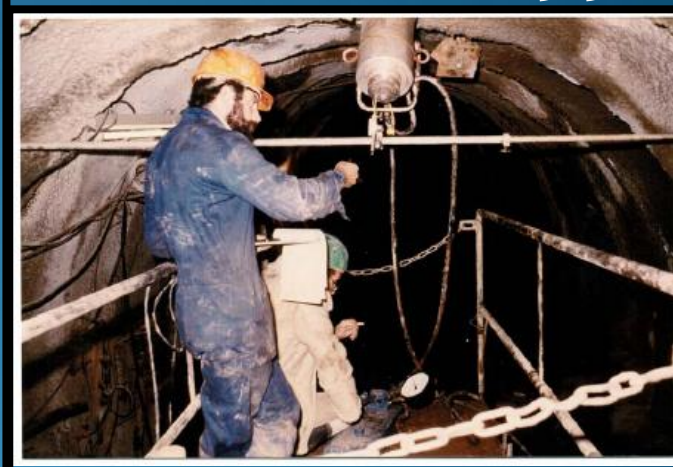
1990

The traditional pull out tests currently used for rock reinforcement quality control / assessment testing is not considered an effective tool for the effective measurement or detection of compromised rockbolt systems used for ground control in mining!!!.

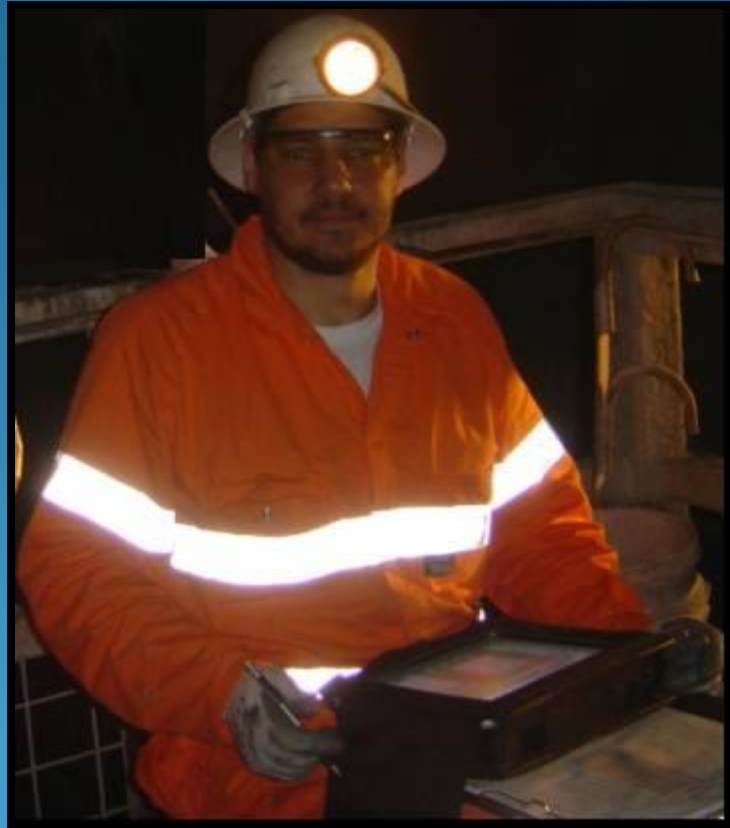
- *A Toughbook / Notebook* - this is used to collect data and providing power via a USB cable for the analogue/digital converter

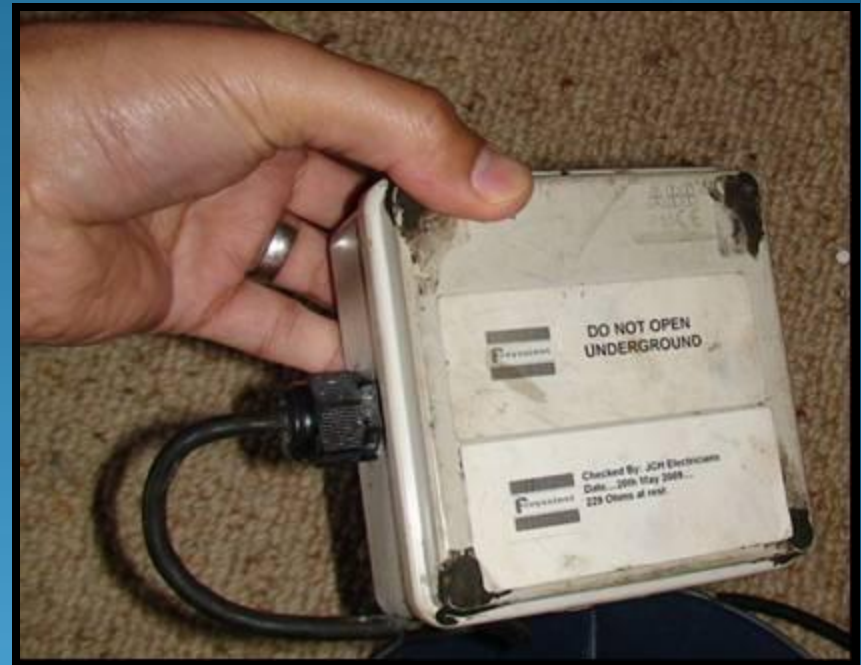
- *Analogue/Digital Converter encased in closed unit - this converts the signal from the transducer into a digital format. The converter is soft wired to the transducer .*

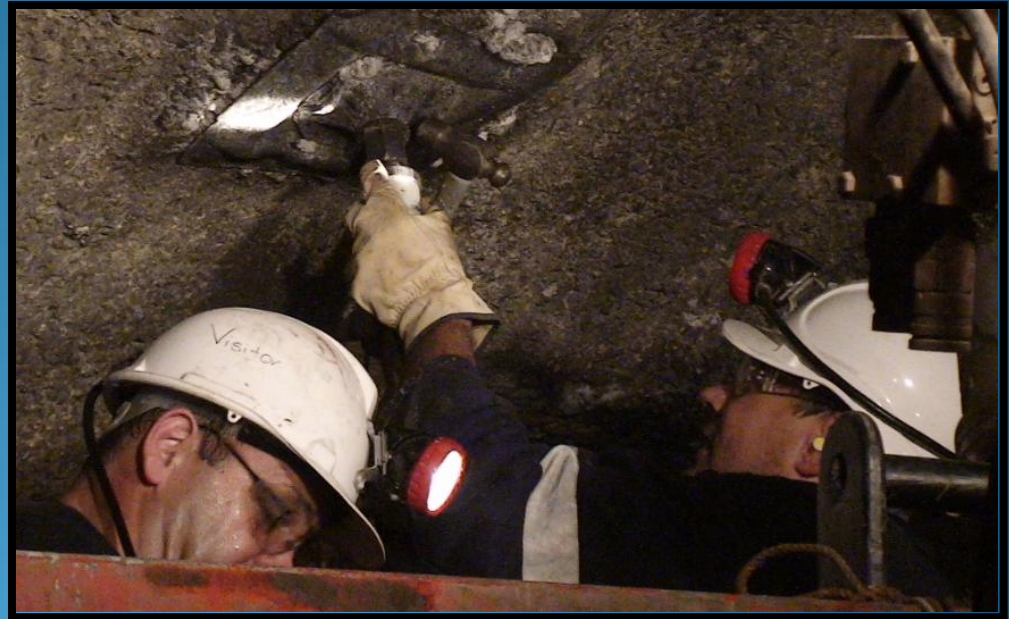
- *Transducer* – which is held at the end of bolt (i.e. collar of hole during the test. A signal / pulse is obtained, which is generated by a tapping device / small hammer.

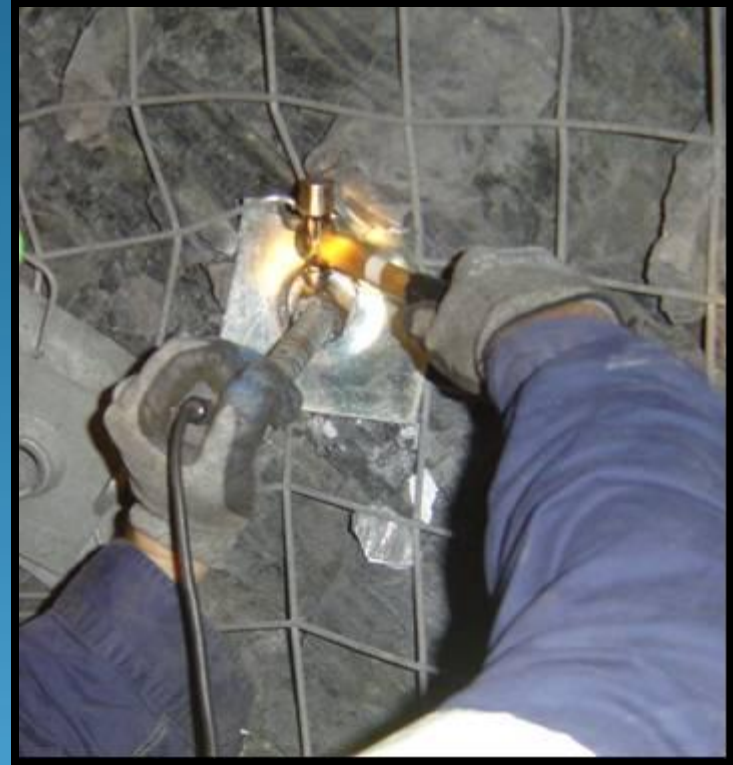
- *The small hammer or tapping device has to make contact against the plate or nut of the bolt during the test.*
