## **Second Ground Control in Mining Conference 2010**

### **Managing Geotechnical Risk through Non-Destructive Rock Reinforcement Testing Trialled at the George Fisher Mine, Mt. Isa.**

*W Hartman, F Harvey, B Lecinq, J Higgs and D Tongue*

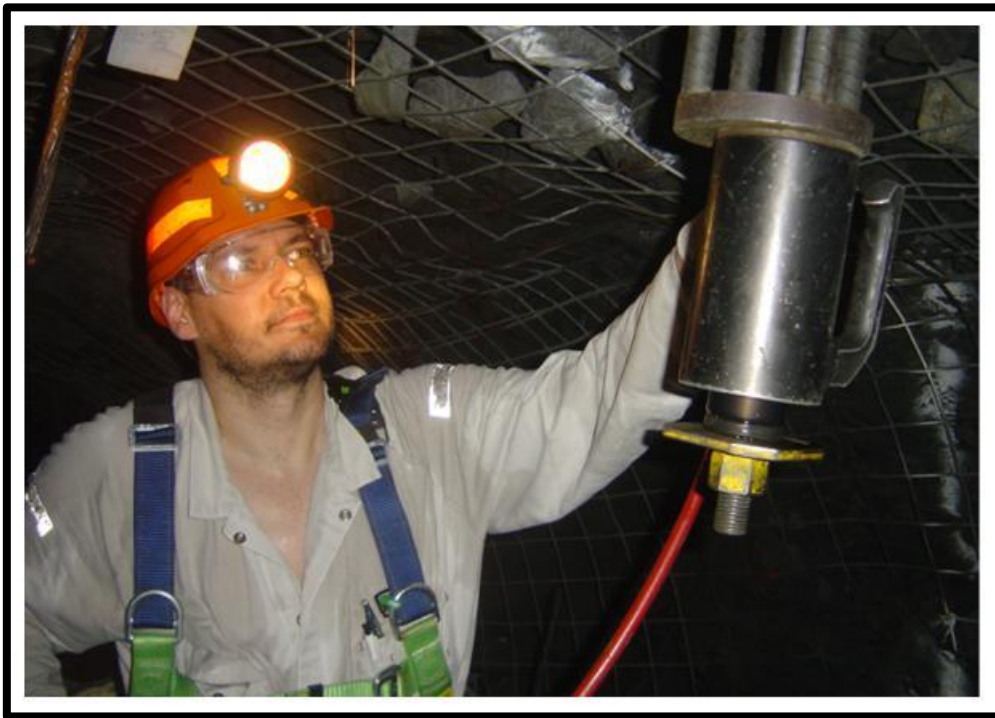
**Fig 1 – Hydraulic Pull testing device used at the George Fisher Mine.**

It has been found through previous studies that corrosion reduces the capacity and life expectancy of ground support (Villaescusa, Hassle and Thompson, 2007) and generally is undetected unless the traditional destructive pull out test (see Figure 1) is employed to detect defect bolts.

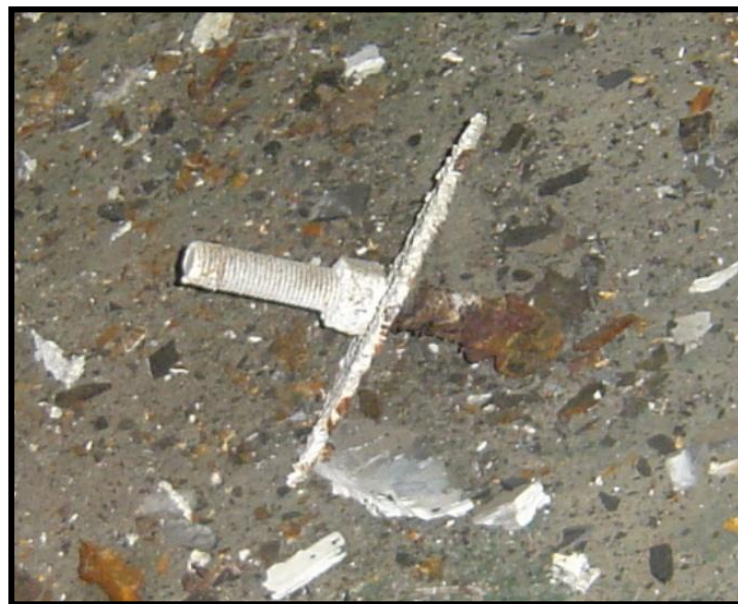
**Fig 10 – Corroded bolt, 16 level crib room.**

16 Level were chosen in particular as the area is subject to very aggressive corrosive conditions. Test Area 2 (Old Crib Room) rock bolts exhibits a high level of corrosion and evidence of this was found in a rock bolt that dislodged from the backs (see Figure 10 - corroded rockbolt).
